# Draft Environmental Monitoring Report

Report: Semestral Report

Reporting Period: 1 January to 30 June 2021

## Sri Lanka: Health System Enhancement Project

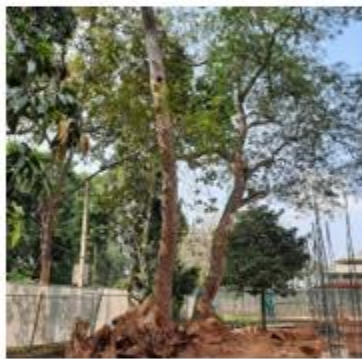
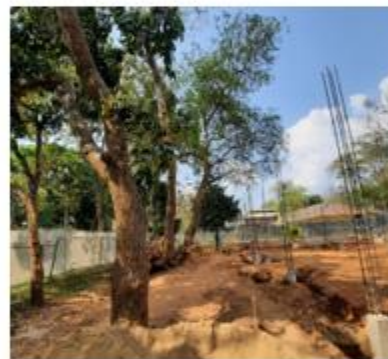
1. Look into the need to cut the existing large trees located close to the frontal boundary of the site premises. These trees are old and apparently have exceeded their growth limits, and the bark of the tree together with major branches look unstable. There is an apparent danger from these trees for the newly constructed building.

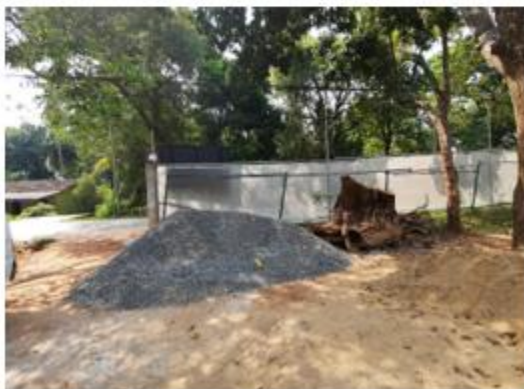
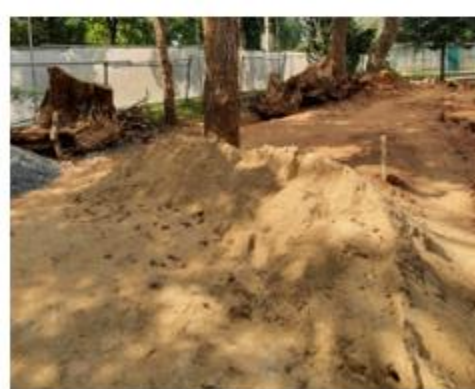
2. There is sand unloaded that has blocked the entrance to the hospital. This should not be done, and the material has to be removed and clear the access road.

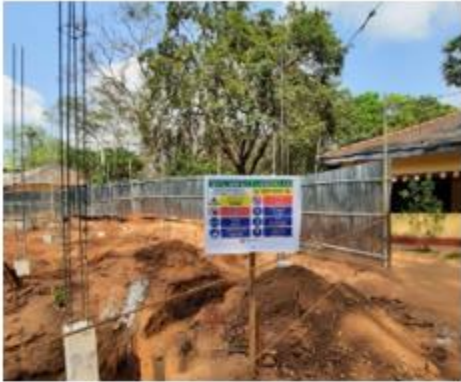
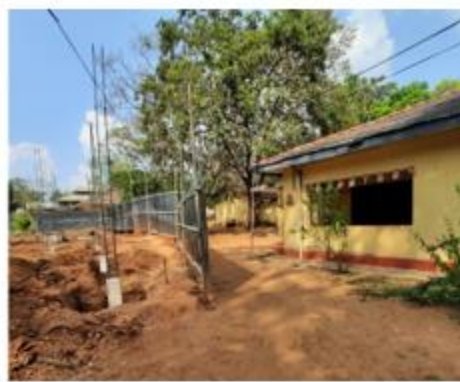
3. Dust barriers have been erected. The height may not be sufficient to prevent dust being blown away towards the buildings in the periphery. Therefore, the windows of the main building facing the project site should be covered appropriately with polyethene.

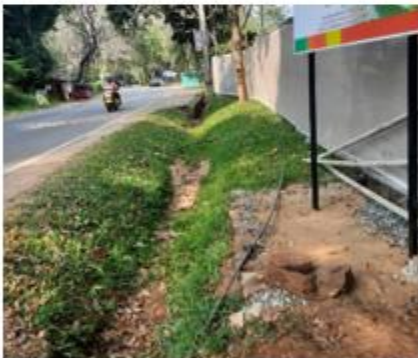
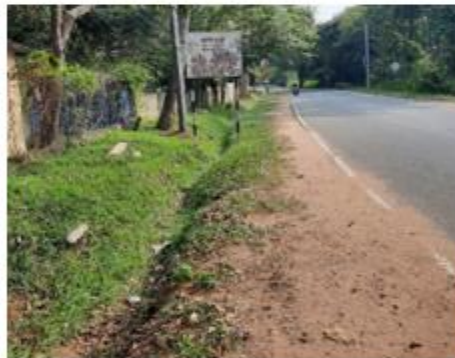
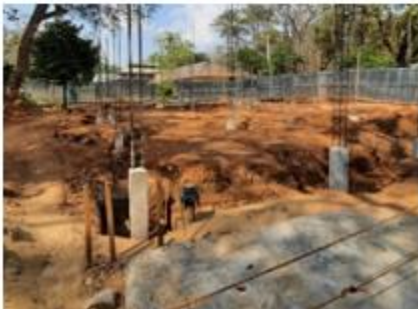
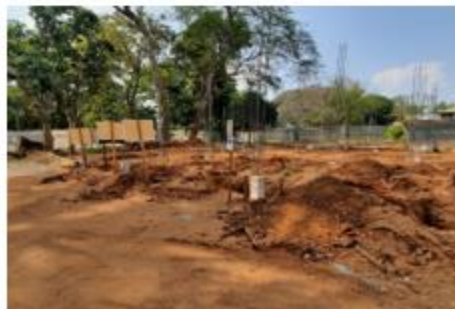
4. No noise generating activities should be planned during OPD hours. The construction site is located very close to quarters and OPD/clinic rooms. The Contractor should discuss and schedule the activities in consultation with the hospital authorities.
5. Site drainage should be planned. Rainwater drains of existing buildings should not be damaged or blocked. In addition, the surface runoff from the site should be collected at a sedimentation basin and should be directed towards the road-side drain. Rainwater drains should be incorporated into designs of the new building.

6. Demolition work has been completed but the demolished building materials and debris are yet to be removed. Also, three stumps and roots are still at the site, and should be removed without delay.

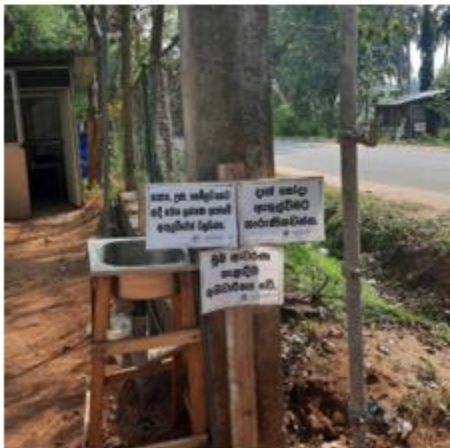
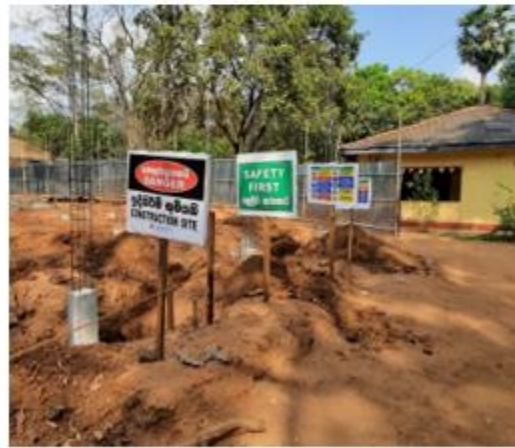
7. The access path (road) to the site has to be properly constructed so that the contractor can unload the material easily within the site premises.
8. The location for the septic tank has to be decided. There is ample space in the periphery of the site.
9. There are warning signs and guidance provided at two prominent locations, however, enforcement of health and safety measures should not be limited to display of sing boards and notices.

10. Sprinkling of water should be done in the event of wind-blown dust is observed.

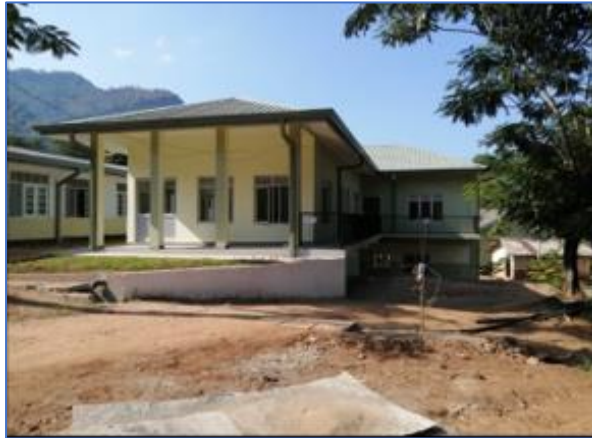
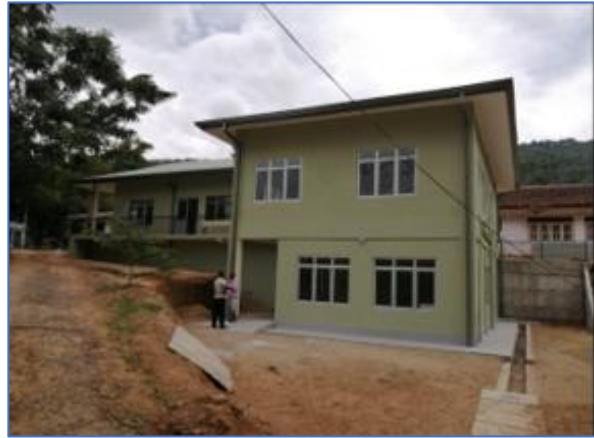
### **(i) Meegahakiula DHB**

The construction of the building is over. Landscaping work remains. Stormwater/rainwater drainage canals have been built.

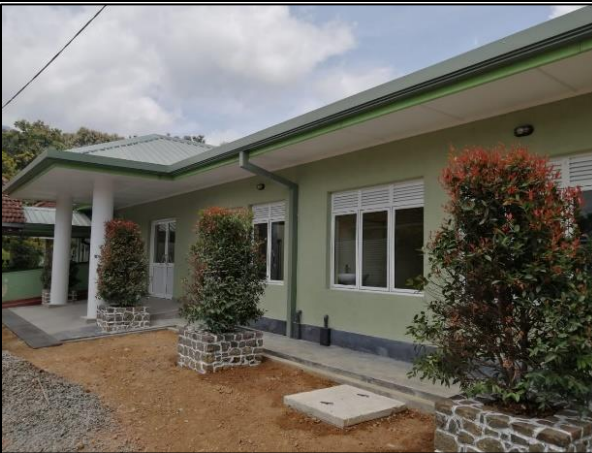
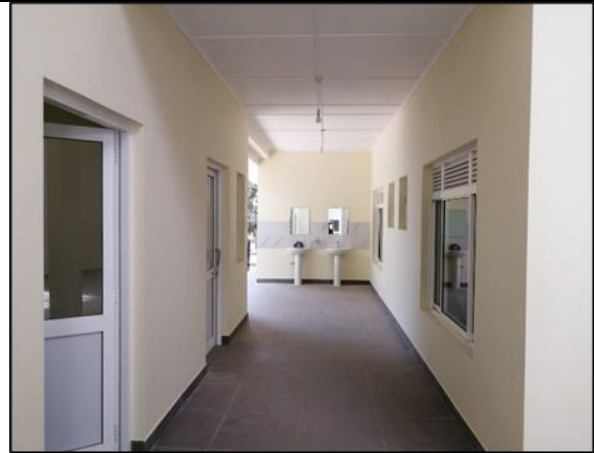
### **(ii) Koslanda DHB**

The sub- and super-structure construction is over. The site premises is kept fairly well. Landscaping work has been completed.

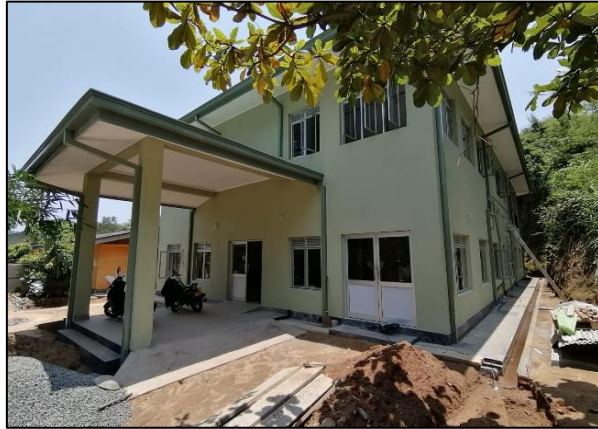
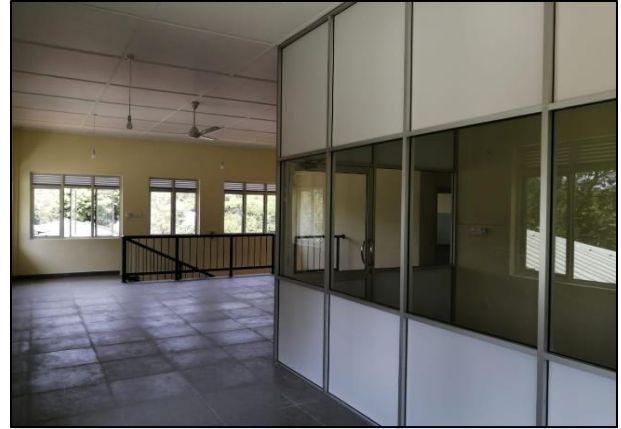
**(iv) Kandeketiya DHB**

Construction of the super-structure and the roof are over. The slopes have been stabilized. Proper rainwater drainage canal needs to be constructed.

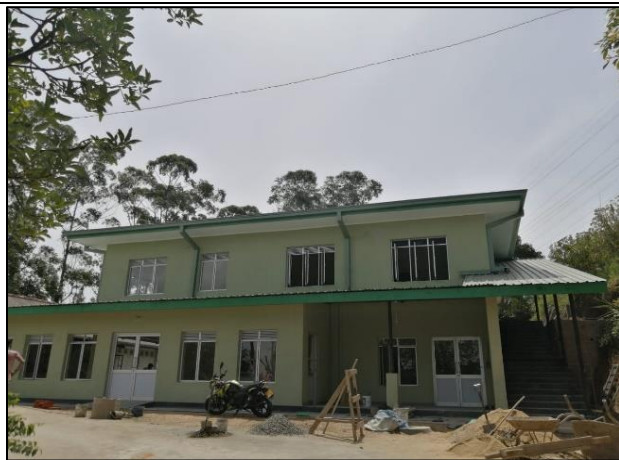
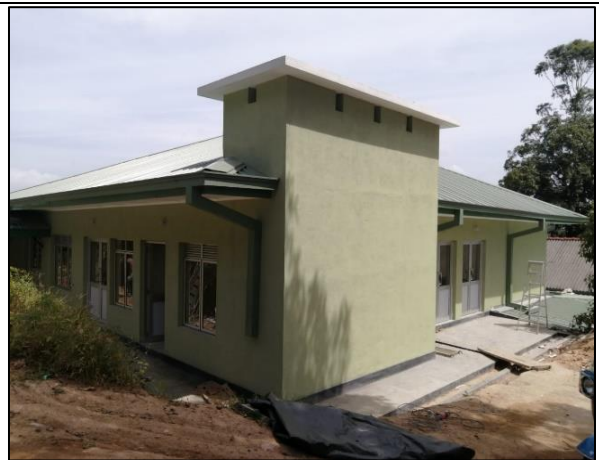
**(v) Etampitiya DHC**

The super-structure construction is over. Retaining wall construction is in progress. Landscaping is yet to be completed.

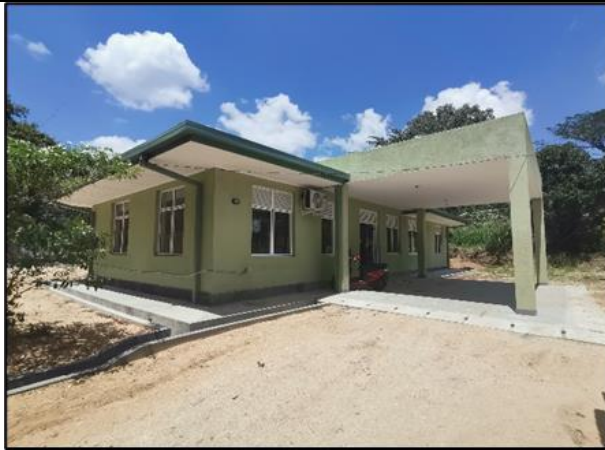
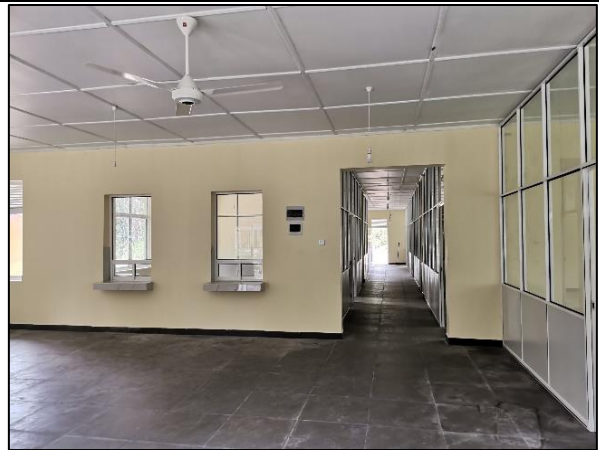
### **(i) Dombagahawela PMCU**

The sub- and super-structure is almost complete. Roof construction is over. Landscaping the peripheral areas is needed. Rainwater drains have been built.

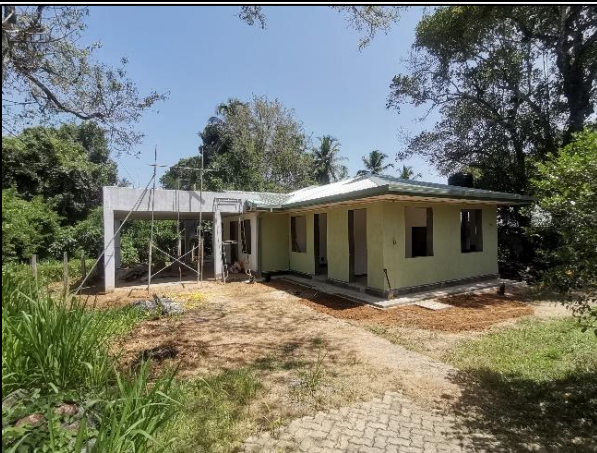
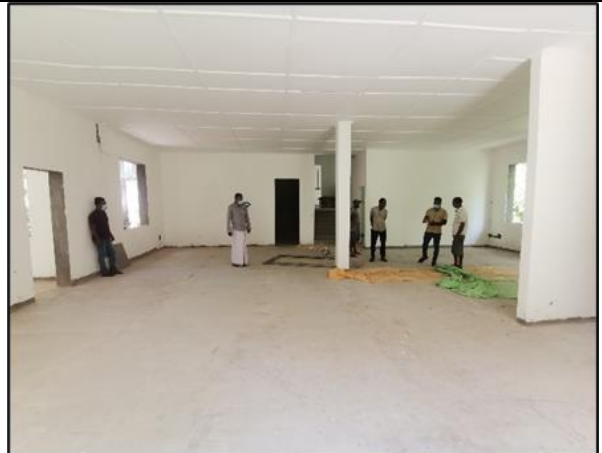
### **(ii) Deliwa PMCU**

The sub- and super-structure has been completed. Roof construction is in progress. Turfing, the peripheral areas is needed.

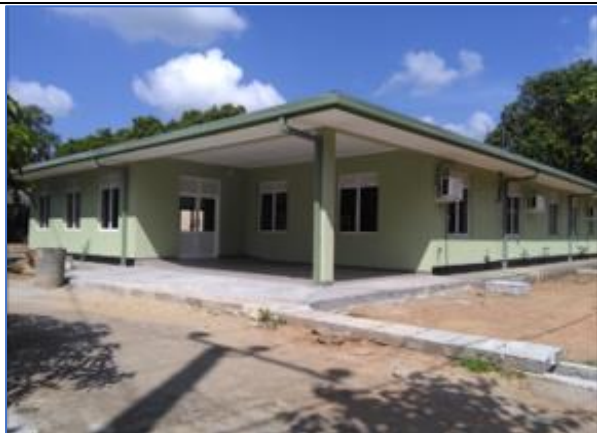
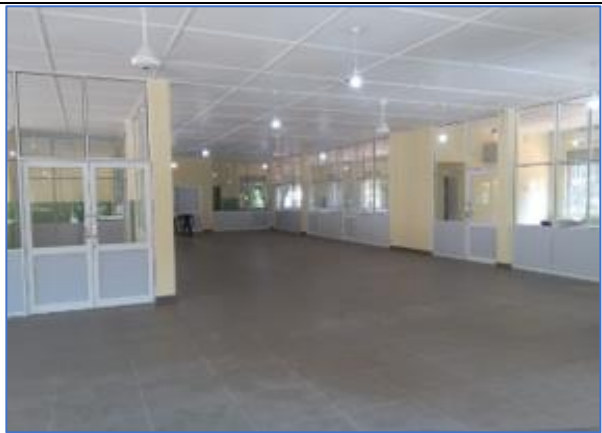
### **(iii) Thanamalwila DHB**

Construction work has been completed. Surrounding areas need to be turfed.

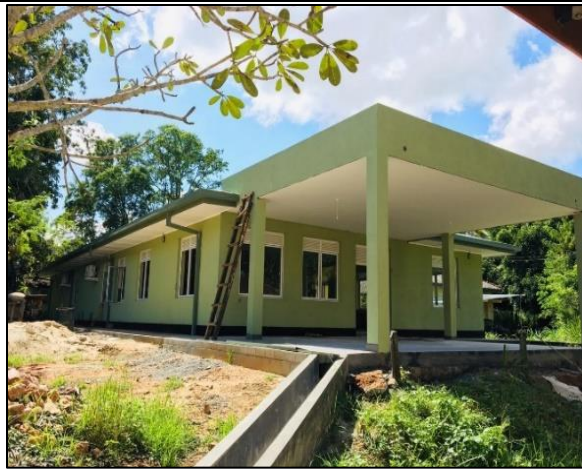
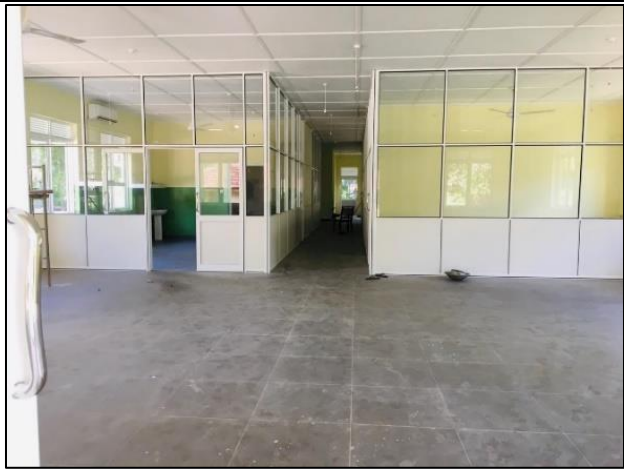
**(iv) Dambagalla DHC**

Building works are completed. No notable environmental issues. Rainwater drains have been built.

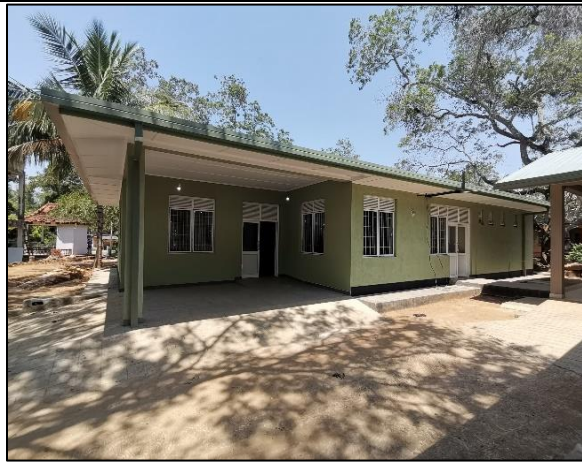
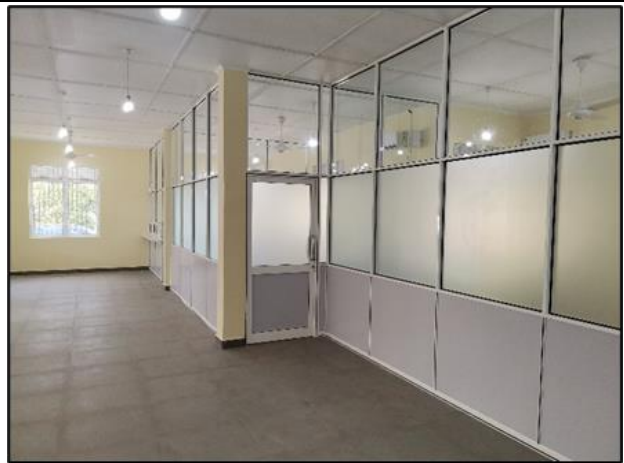
**(v) Hambegamuwa PMCU**

The construction is over. The site premises is kept fairly well. No environmental issues observed

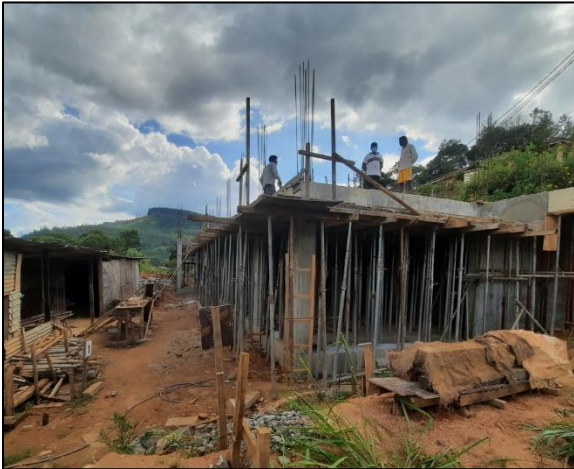
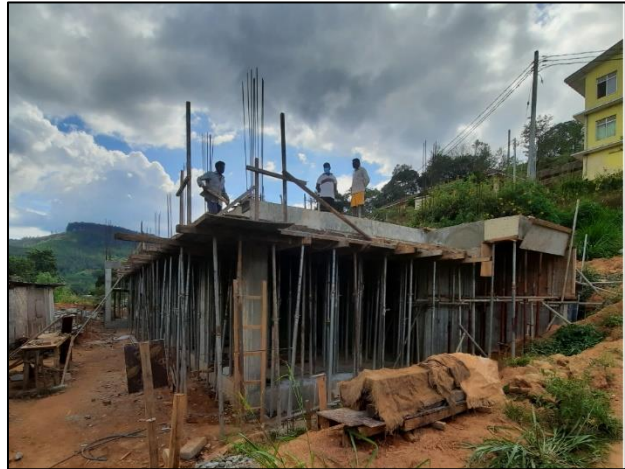
### **(i) Madulkele DHB**

The progress of the site works has been slow due to design issues. The slopes are not stable and prone to erosion. Demolished timer and asbestos sheets are still to be disposed of. Concreting and superstructure construction is in progress.

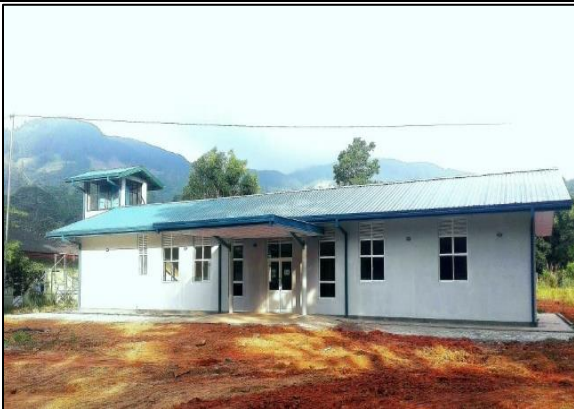
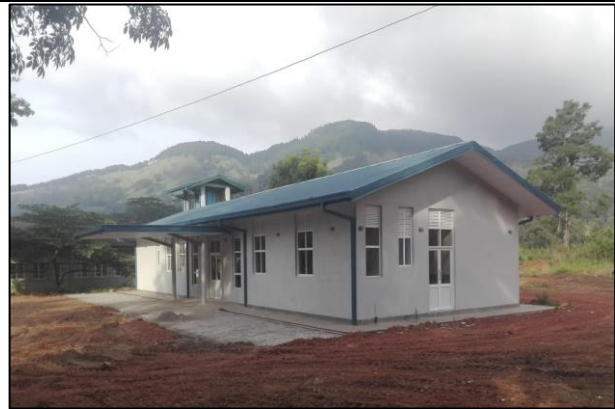
### **(ii) Galaha DHC**

The construction work is over. The site premises is kept fairly well. Some landscaping work is needed

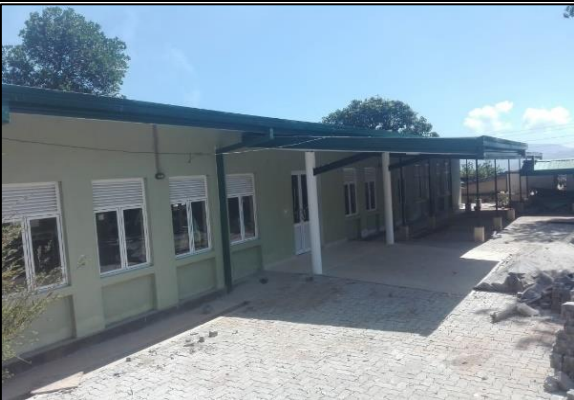
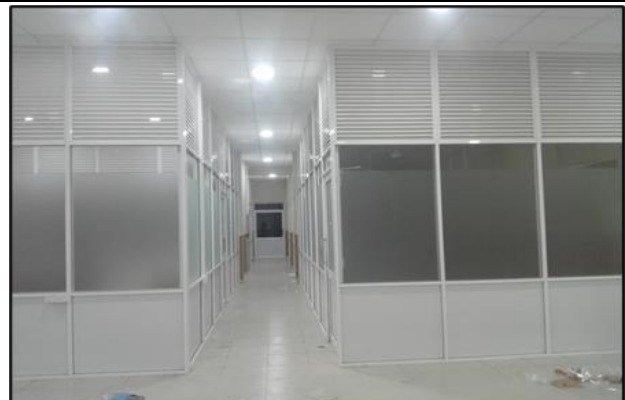
### **(iii) Deltota DHB**

The work is almost finished. Finishes and fittings to be completed. Door and window fittings and partitioning work completed. Cleaning the site is needed prior to handing over.

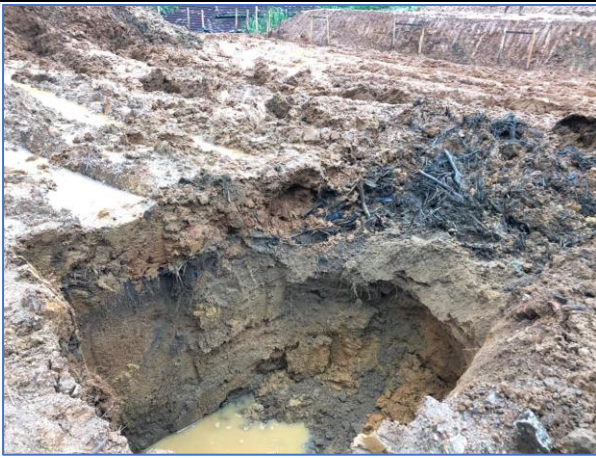
**(iv) Dolosbage DHC**

Bulk excavation for site preparation is completed. Soil heaps are still lying at the premises. Slopes are unstable and need stabilization. Work temporary suspended due to unstable slopes and high groundwater table.

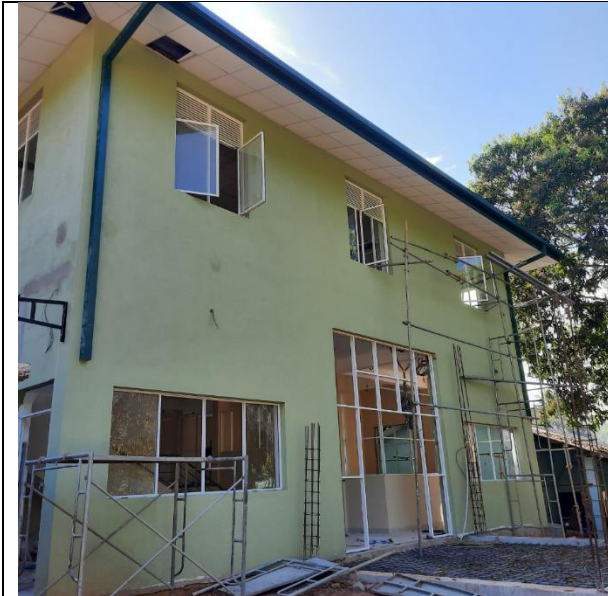
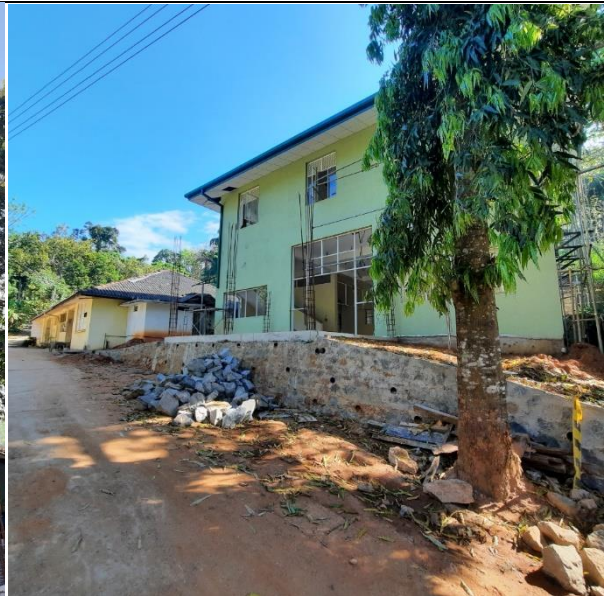
**(v) Hataraliyedda DHC**

The super-structure construction is over. Finishing work is in progress. The site premises is kept fairly well. Material heaps are not kept covered, and the barriers/fence of the site towards the hospital has not been erected.

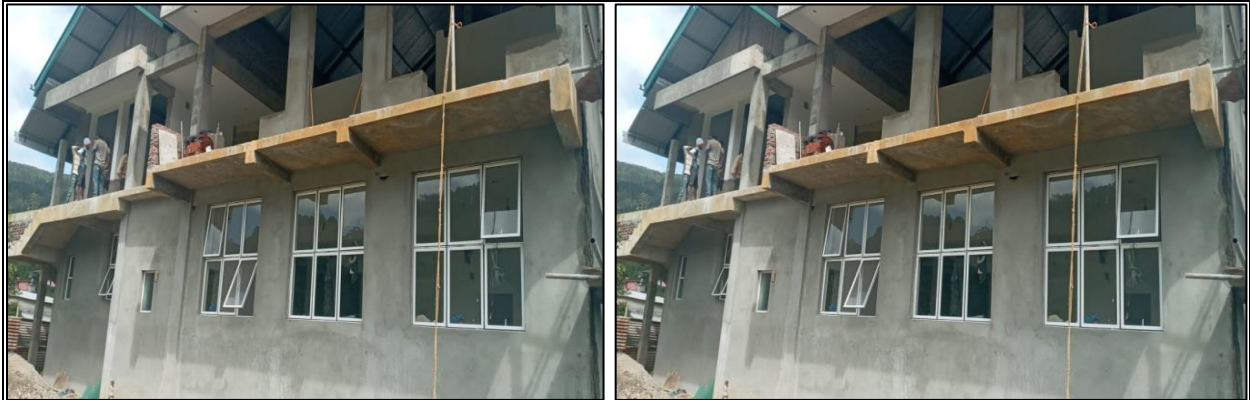
### **(i) Nanu Oya PMCU**

The super-structure construction is in progress. Demolished material has been mostly removed from the site. The barriers of the site are not in proper condition. The large tree on the frontal boundary to be removed.

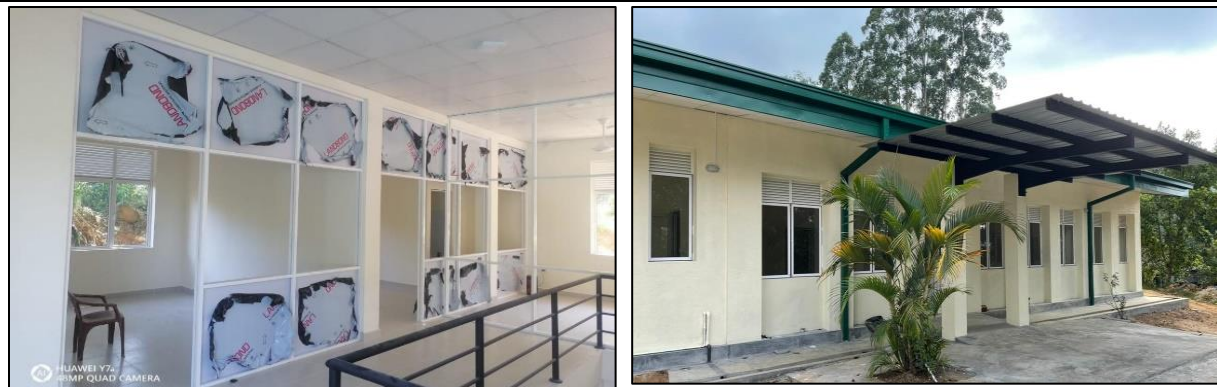
### **(ii) Pundalu Oya PMCU**

The construction is almost over. The site premises is kept fairly well. The peripheral areas need to be turfed.

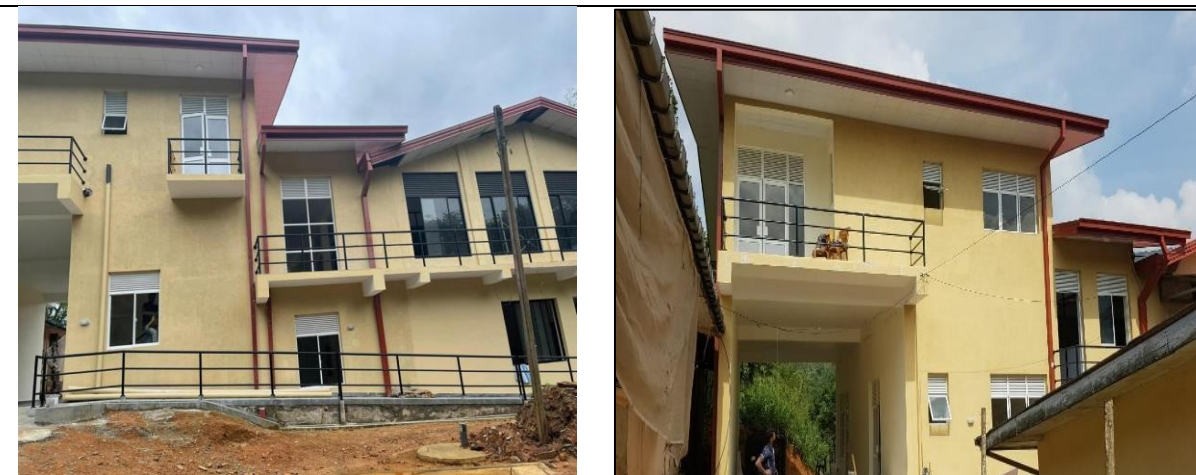
### **(iii) Laxapana DHC**

The construction work is over. The site premises is kept fairly well. Material heaps are not kept covered, and there are areas which are prone to erosion. Slopes should be turfed.

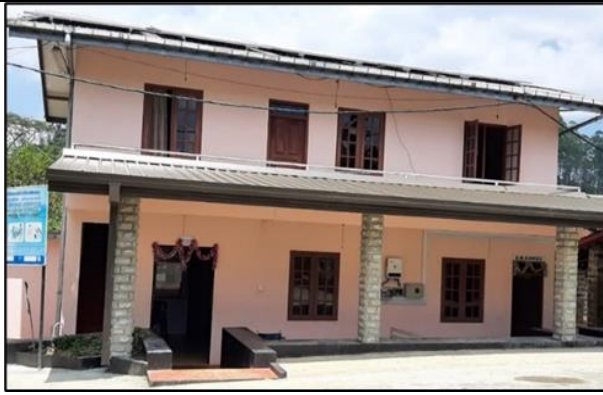
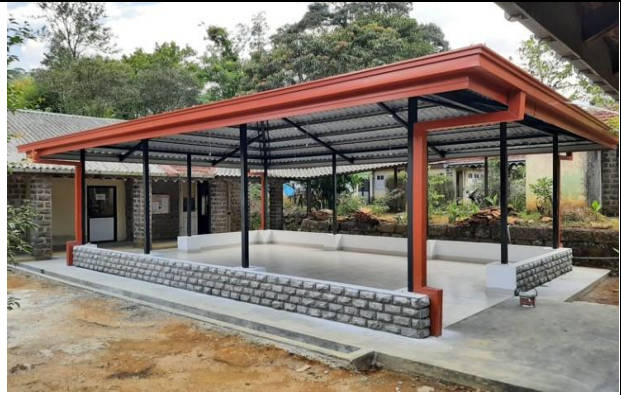
**(iv) Kotagala DHC**

The construction work of the ETU located near the entrance is almost complete. Finishing works are in progress. The patients' waiting area is under construction. No significant environmental impacts have been observed. The work is carried out mostly during the after hours.

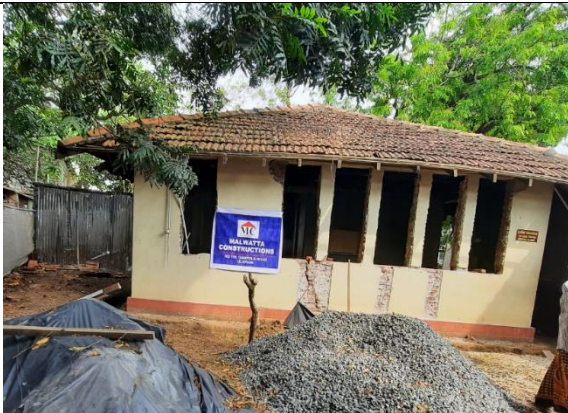
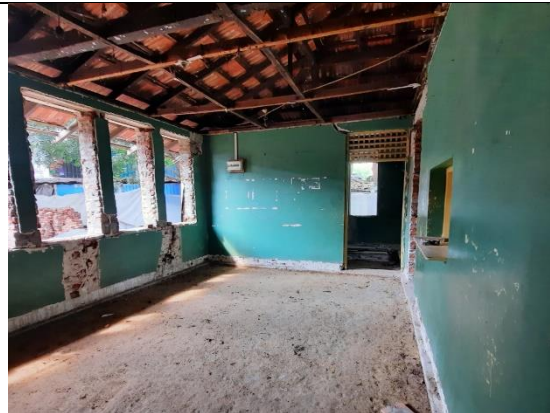
**(i) Galewela DHC**

The renovation works are in progress.

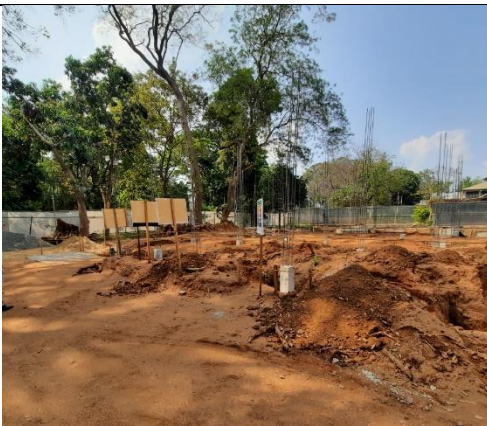
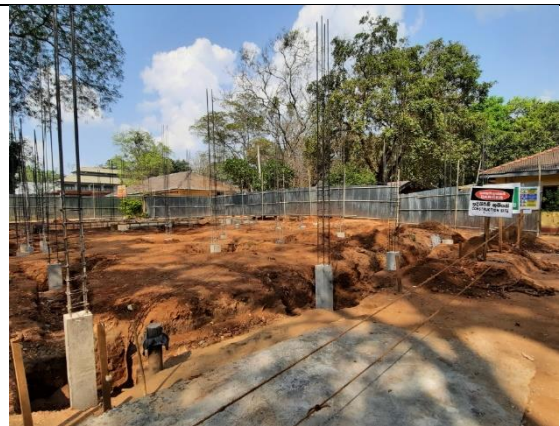
**(ii) Sigiriya-Kimbissa DHC**

Foundation works are in progress

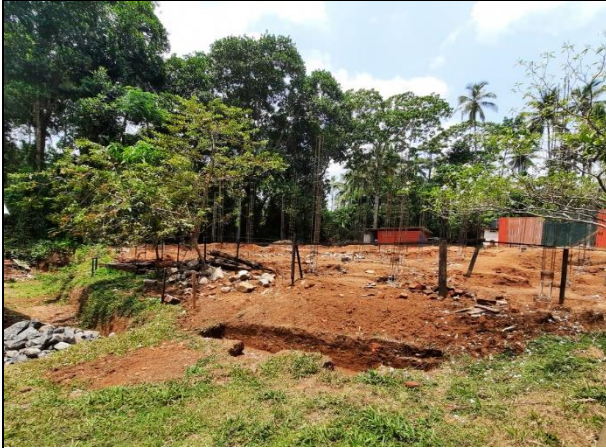
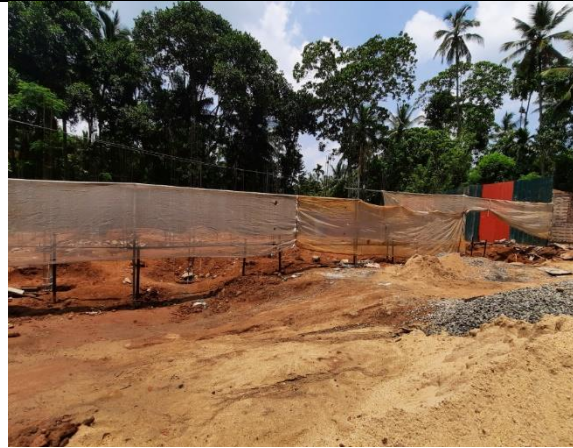
**(iii) Paldeniya PMCU**

Foundation and sub-structure works are in progress

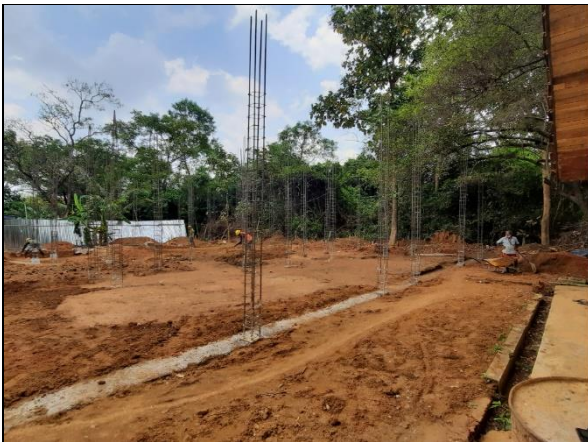
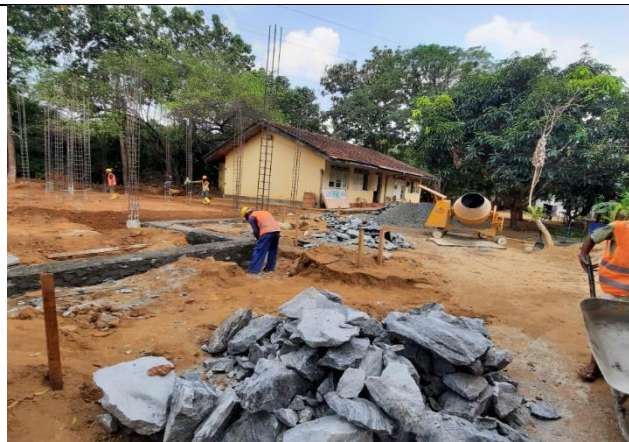
**(iv) Kalundewa PMCU**

Foundation work and column construction is in progress

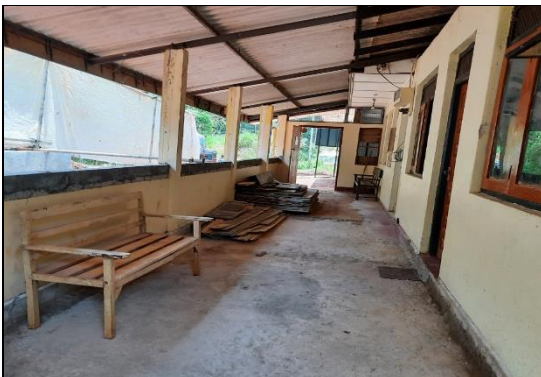
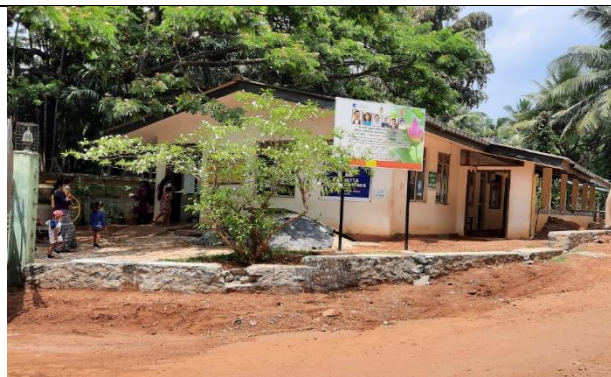
**(v) Madawalaulpotha PMCU**

Renovation works in in progress

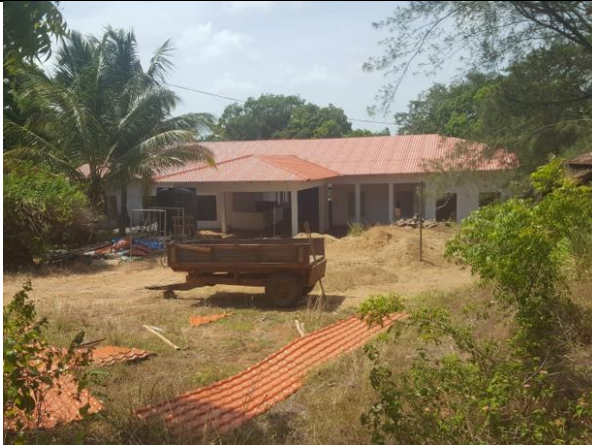
### **(i) Horowpathana DHC**

The construction progress has been slow. The site premises should be kept tidy and free of areas where water stagnation is possible. Parts of the demolished sections should be properly renovated.

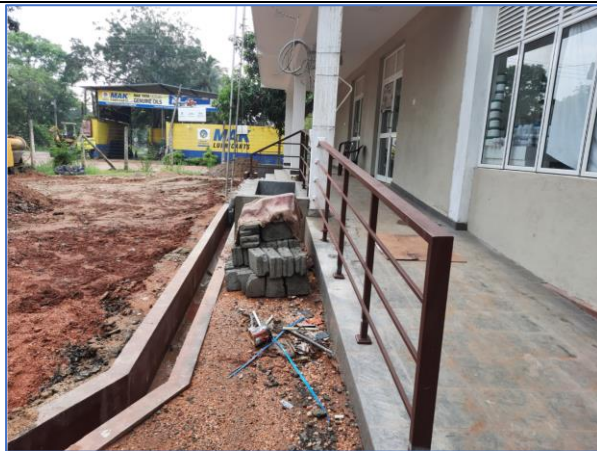
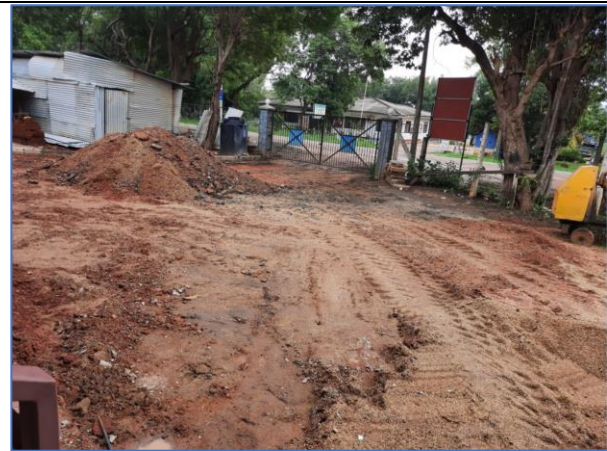
### **(ii) Galenbindunuwewa DHB**

The construction work is almost over. Peripheral areas to be filled and levelled once the construction work is completed. (Photo taken in Januray 2021)

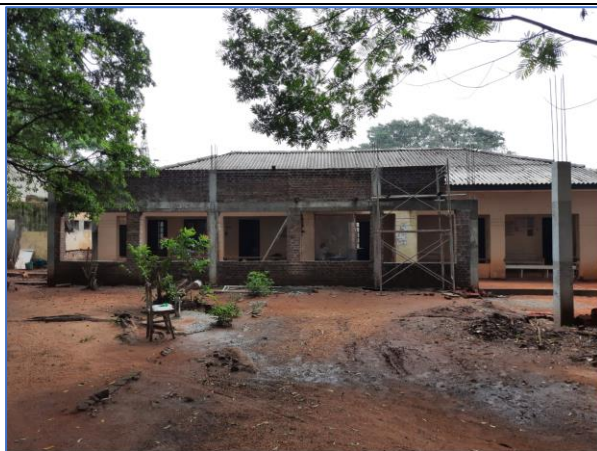
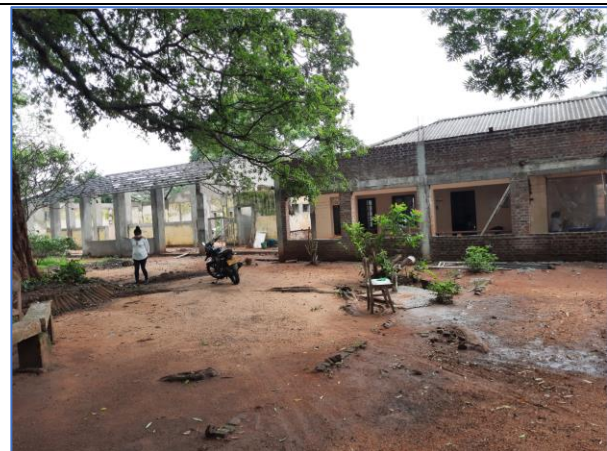
### **(iii) Koonwewa PMCU**

The work of the first phase has been completed. The patients are inconvenienced due to construction work until the new construction work, and renovation work are completed. (Photo taken in Januray 2021)

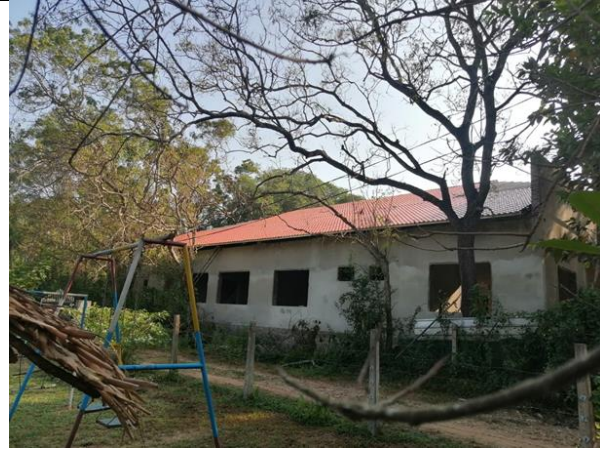
**(iv) Negampaha DHC**

Finishing work is in progress. Rainwater drains have to be constructed.

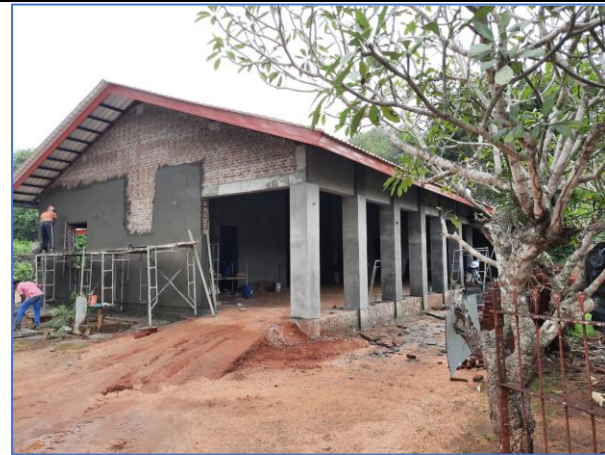
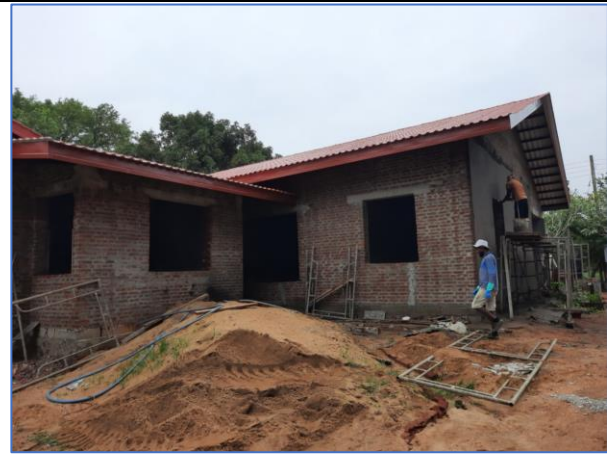
**(v) Tittagonewa PMCU**

The construction is over. The site premises is kept fairly well. Rainwater drains are constructed. Landscaping to be done.

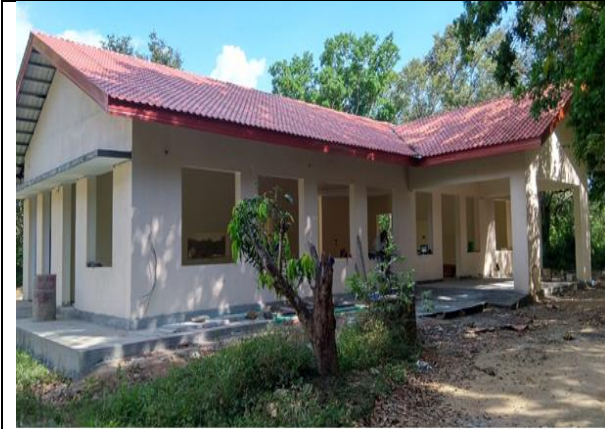
### **(i) Ellewewa PMCU**

The progress of the site works has been satisfactory and construction is almost over.

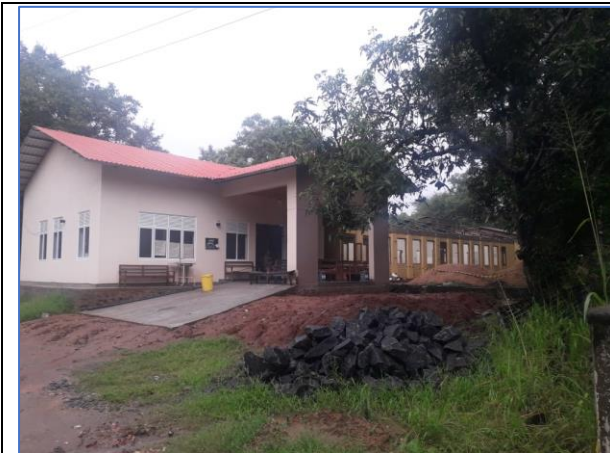
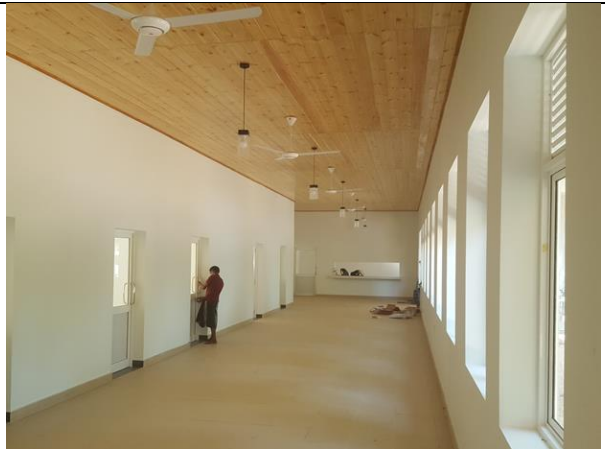
### **(ii) Sevanapitiya PMCU**

The construction is over. Only the roof construction of part of the building remains. The site premises is kept fairly well. Some landscaping and turfing are needed in areas where the soil is exposed.

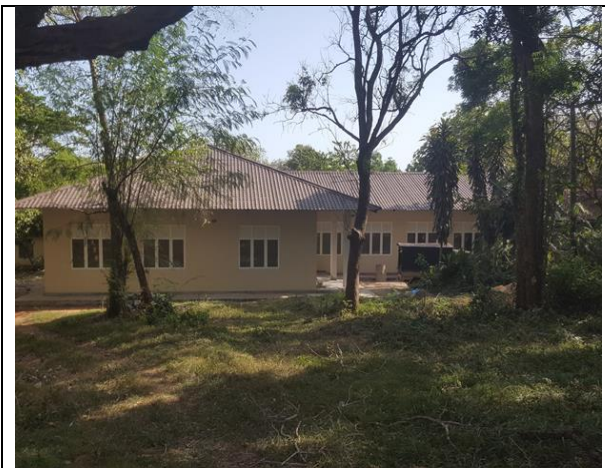
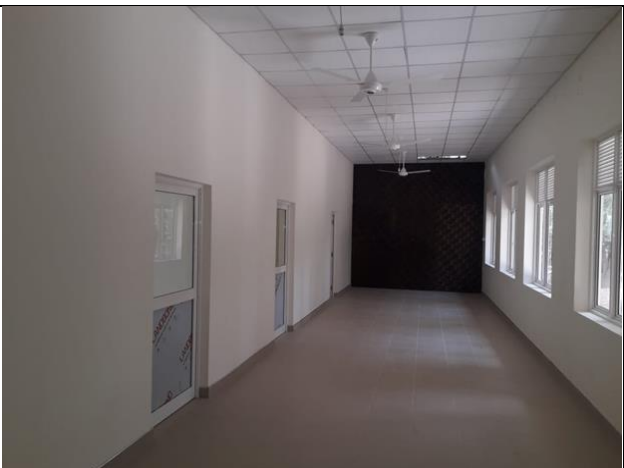
### **(iii) Damminna PMCU**

There has been good progress since the last visit. There is construction debris around the periphery has been removed. The civil works has been completed.

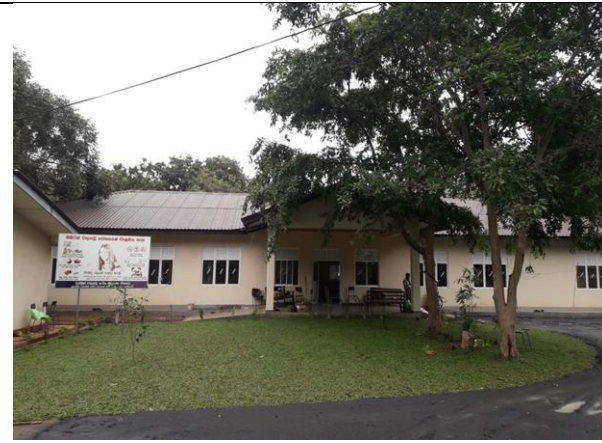
**(iv) Ambagaswewa DHC**

Construction work is over. Only minor works are remaining for finishing and fixing of electrical fittings.

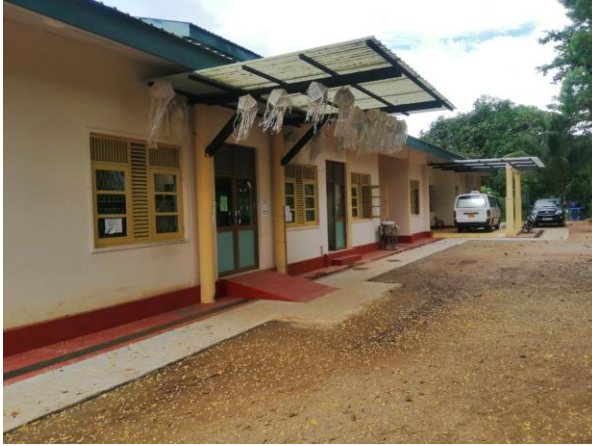
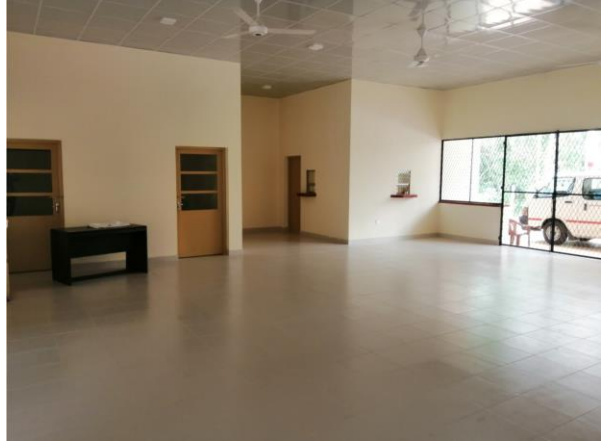
### **(i) Endana DHC**

The new construction is over. The site premises and the peripheral areas have to be turfed. The renovation of the existing building is in progress. No significant environmental issues.

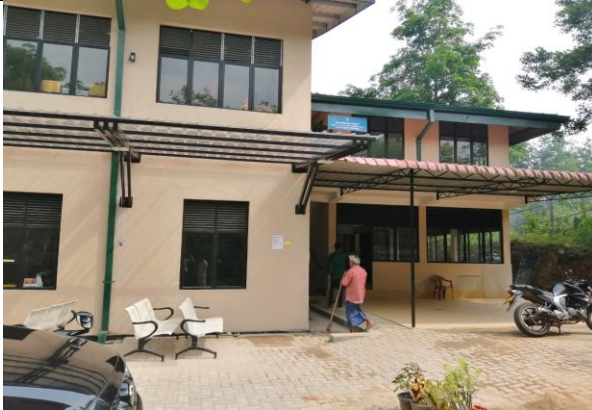
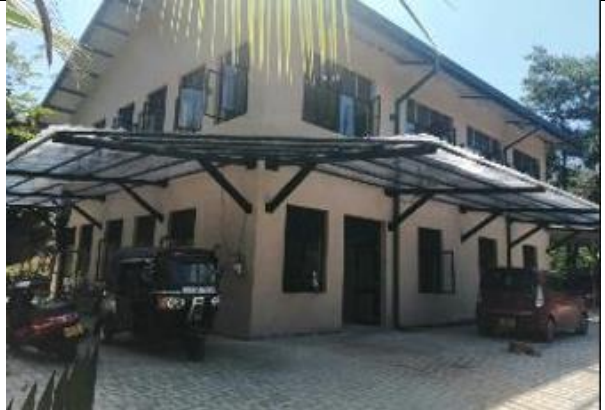
### **(ii) Dodampe PMCU**

The construction is over. The site premises is kept fairly well. Finishing works (b. Balance paint, Aluminum works, Electrical works) in progress. No major environmental issues noted.

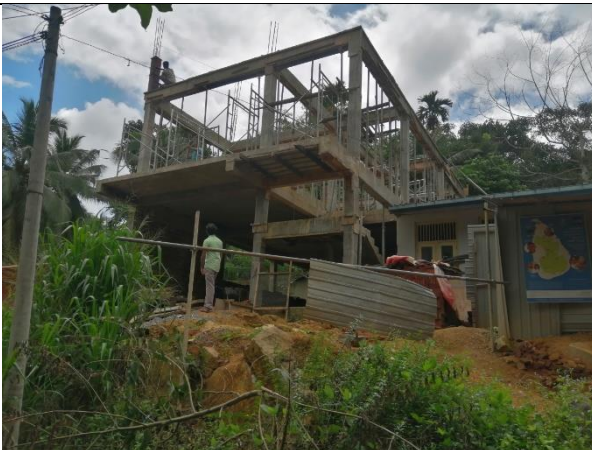
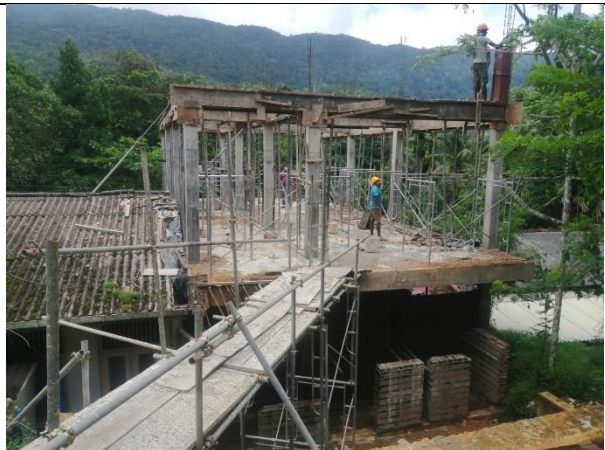
### **(iii) Delwala PMCU**

Demolition work has been completed, but the demolished building materials and debris have been removed. Superstructure is being constructed. Fencing to barricade the neighbourhood is needed.

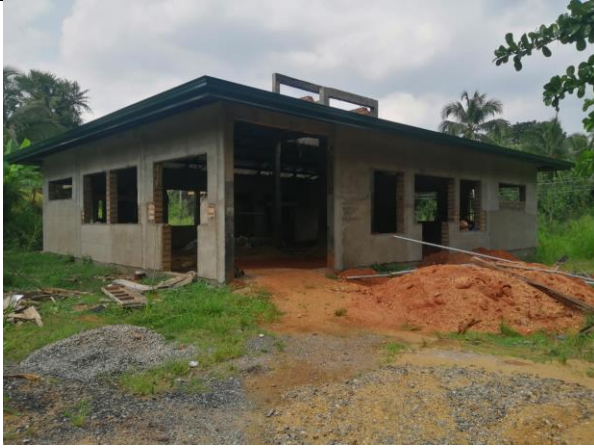
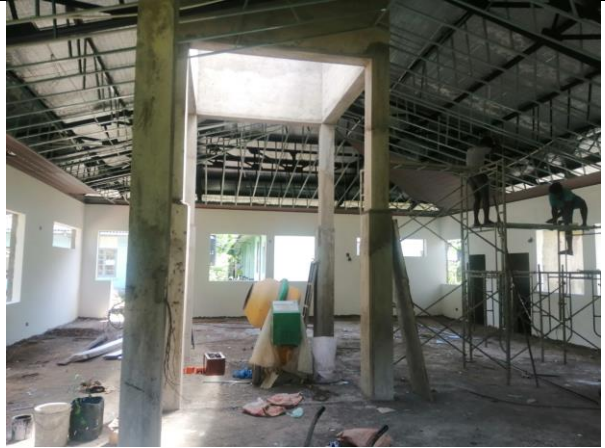
**(iv) Ranwala DHC**

Roof Beam construction and Brickworks in progress. Much of the debris is yet to be removed. Fencing to barricade the neighbourhood is needed.

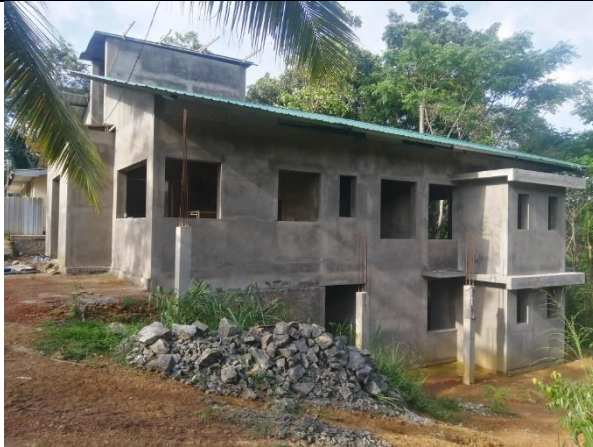
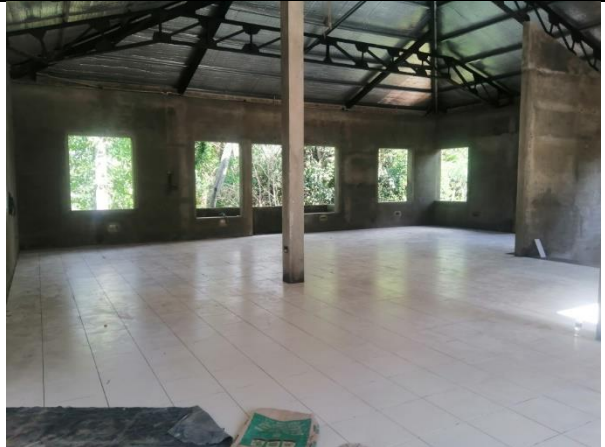
**(v) Narissa PMCU**

The super-structure construction has been completed. The site premises is kept fairly well. Finishing work and ceiling work in progress. Slope protection towards the steep slope in front of the new building is needed. Retaining walls have been erected.
