# Draft Environmental Monitoring Report

Report: Semestral Report

Reporting Period: 1 January to 30 June 2021

## Sri Lanka: Health System Enhancement Project

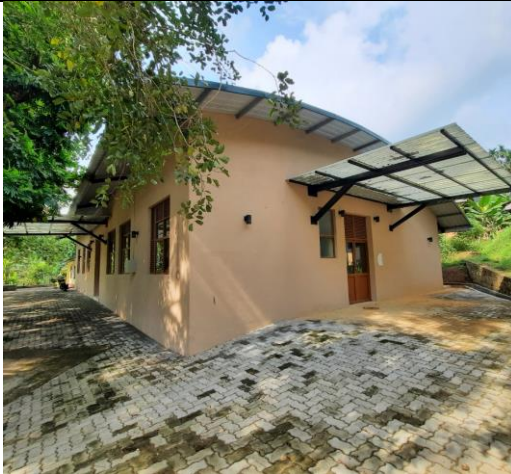
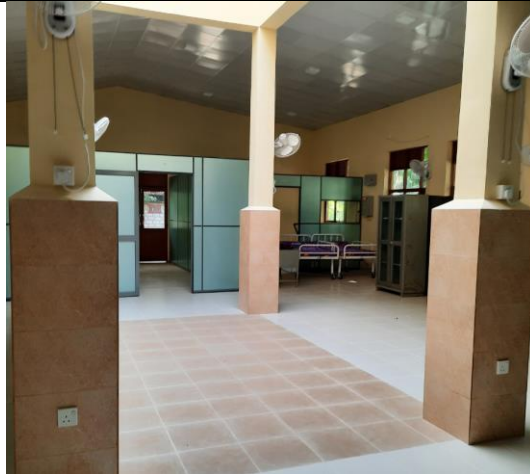
### **(i) Hewadiwela PMCU**

The construction work is over. The peripheral areas have been paved.

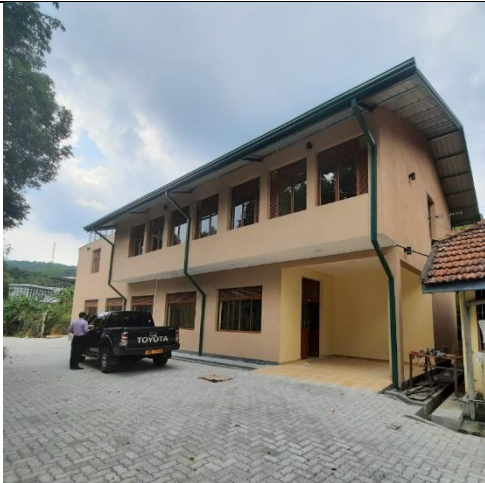
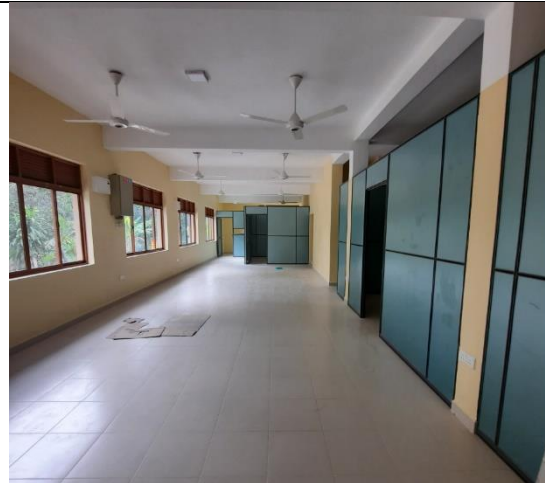
### **(ii) Minuwangama PMCU**

The sub- and super structure construction are over. The floor construction, Ground floor, Toilet tiling works, internal painting works, Ceiling work in progress.

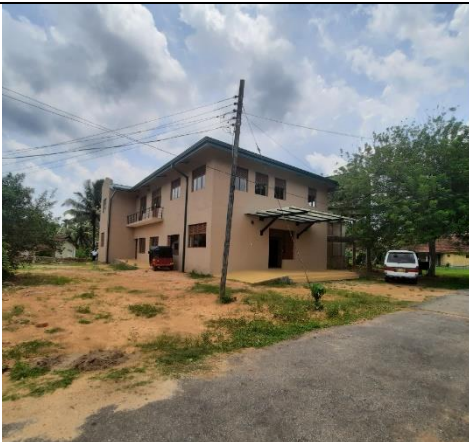
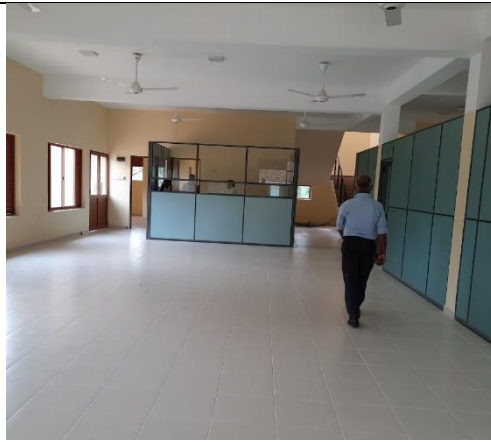
### **(iii) Aranayake DHA**

Balance Aluminum works, Car poach and disable ramps construction. Site premises is noted to be fairly well-managed, no environmental issues observed.

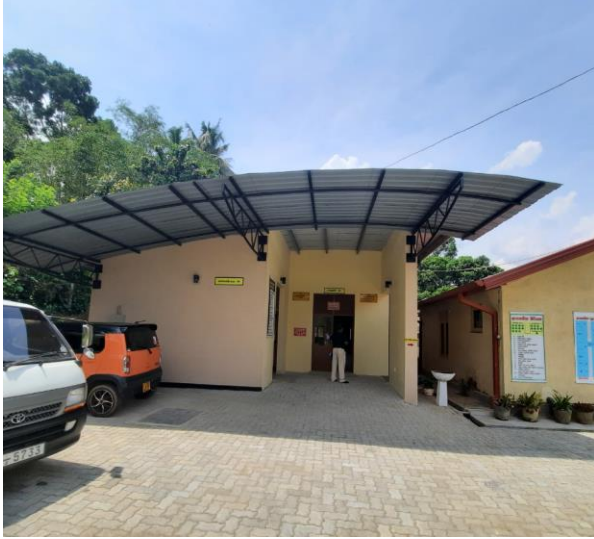
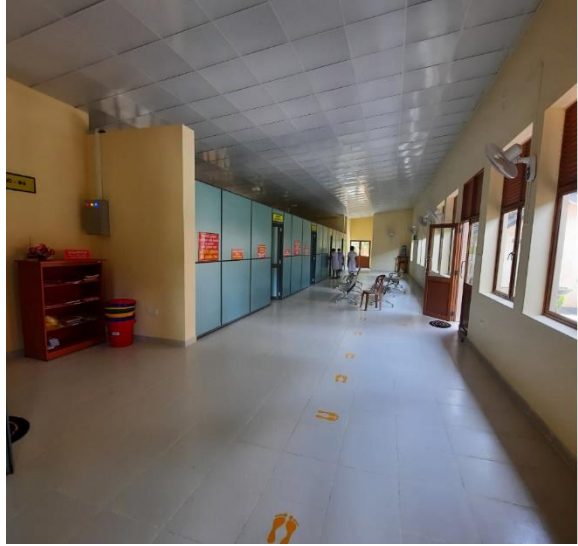
(iv) Bolagama PMCU

Construction work has been completed. No remaining work. Peripheral areas have been cleaned.
